Sanatorium Zonnestraal

the history and restoration
of a modern monument

179	4.3	The Restoration Concept Wessel de Jonge and Hubert-Jan Henket
185	4.4	The Restoration Wessel de Jonge and Hubert-Jan Henket

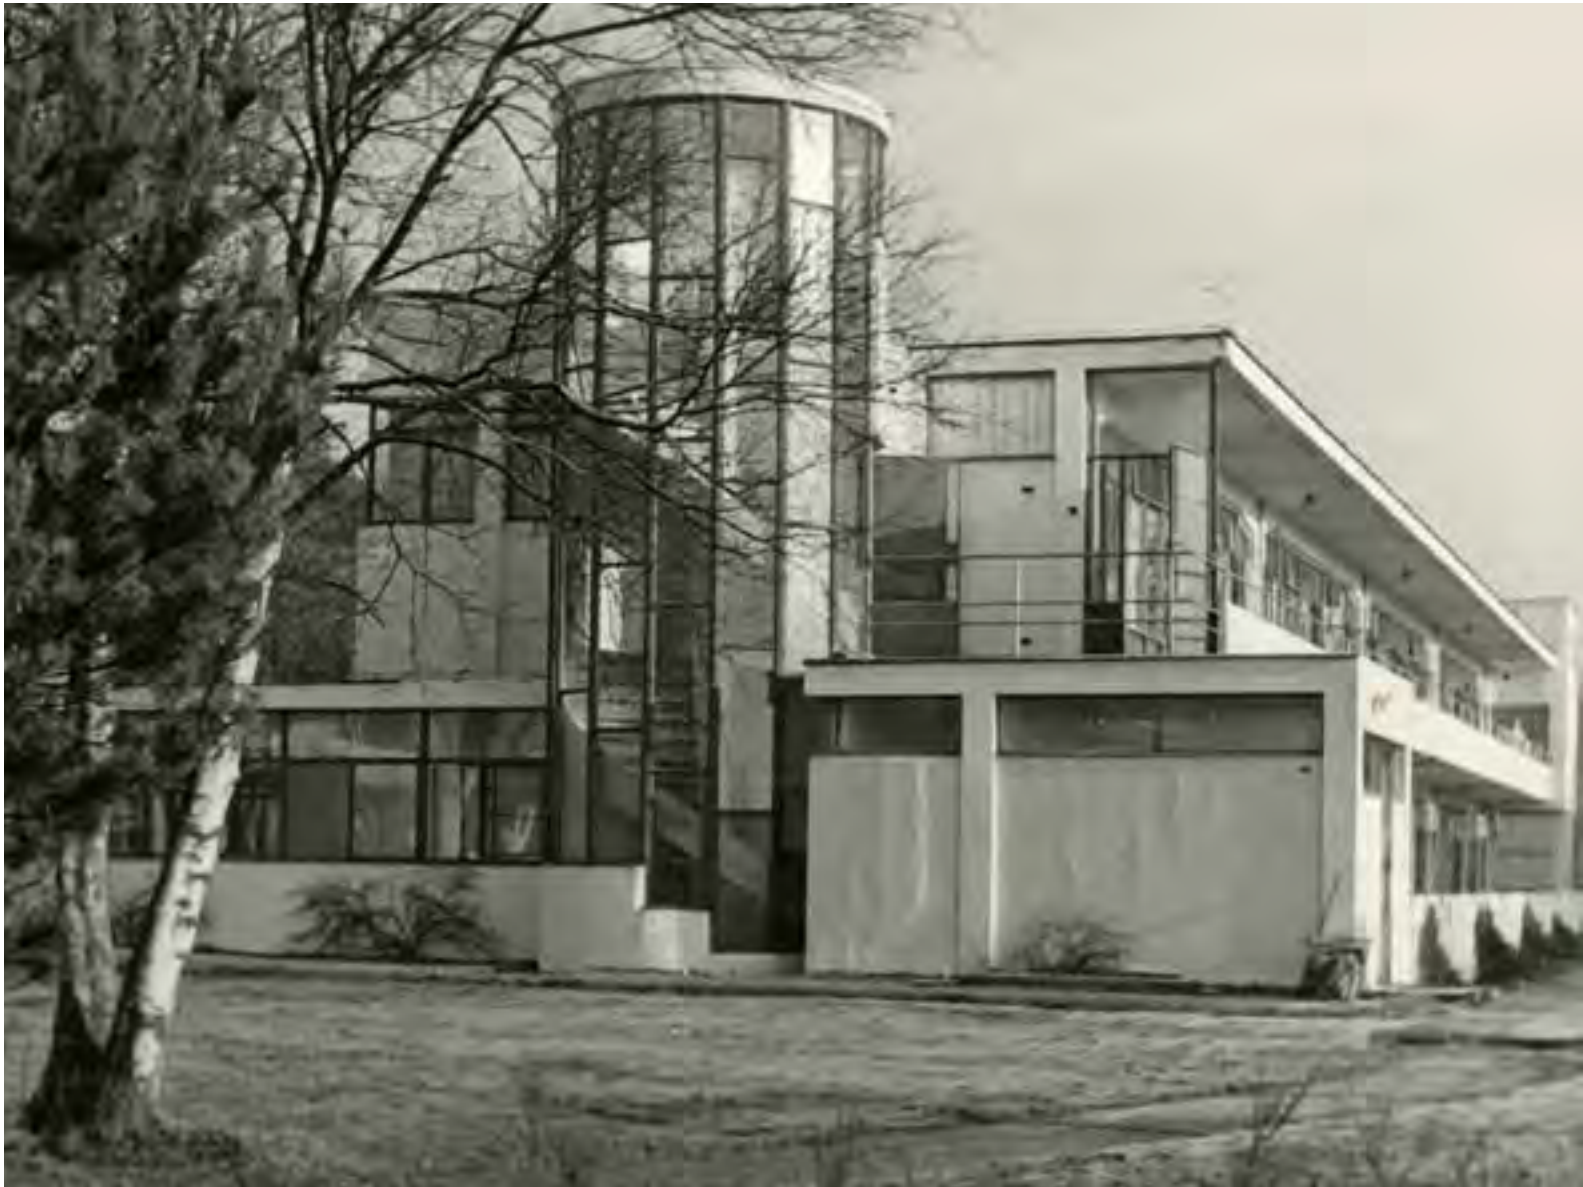
17 The western elevation of the square wing of the Dresselhuys Pavilion shortly after painting. The rich texture of the plastered parapets is striking evidence of work done by hand.

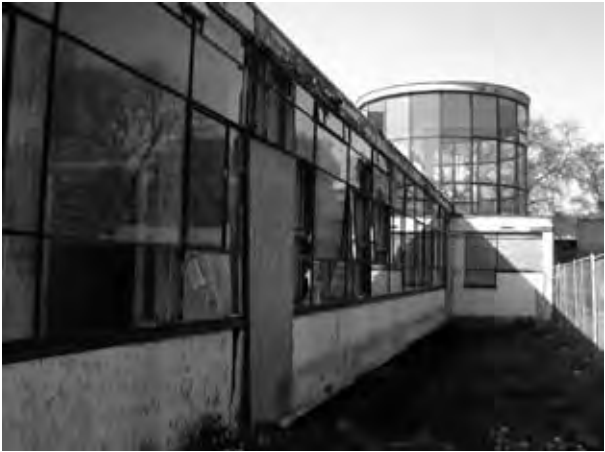
18 The demolition of the day clinic designed by the architect J.P. Kloos in the 1960s brought to light an original façade fragment that had been preserved between two partition walls, making it possible to determine many original details and colours.

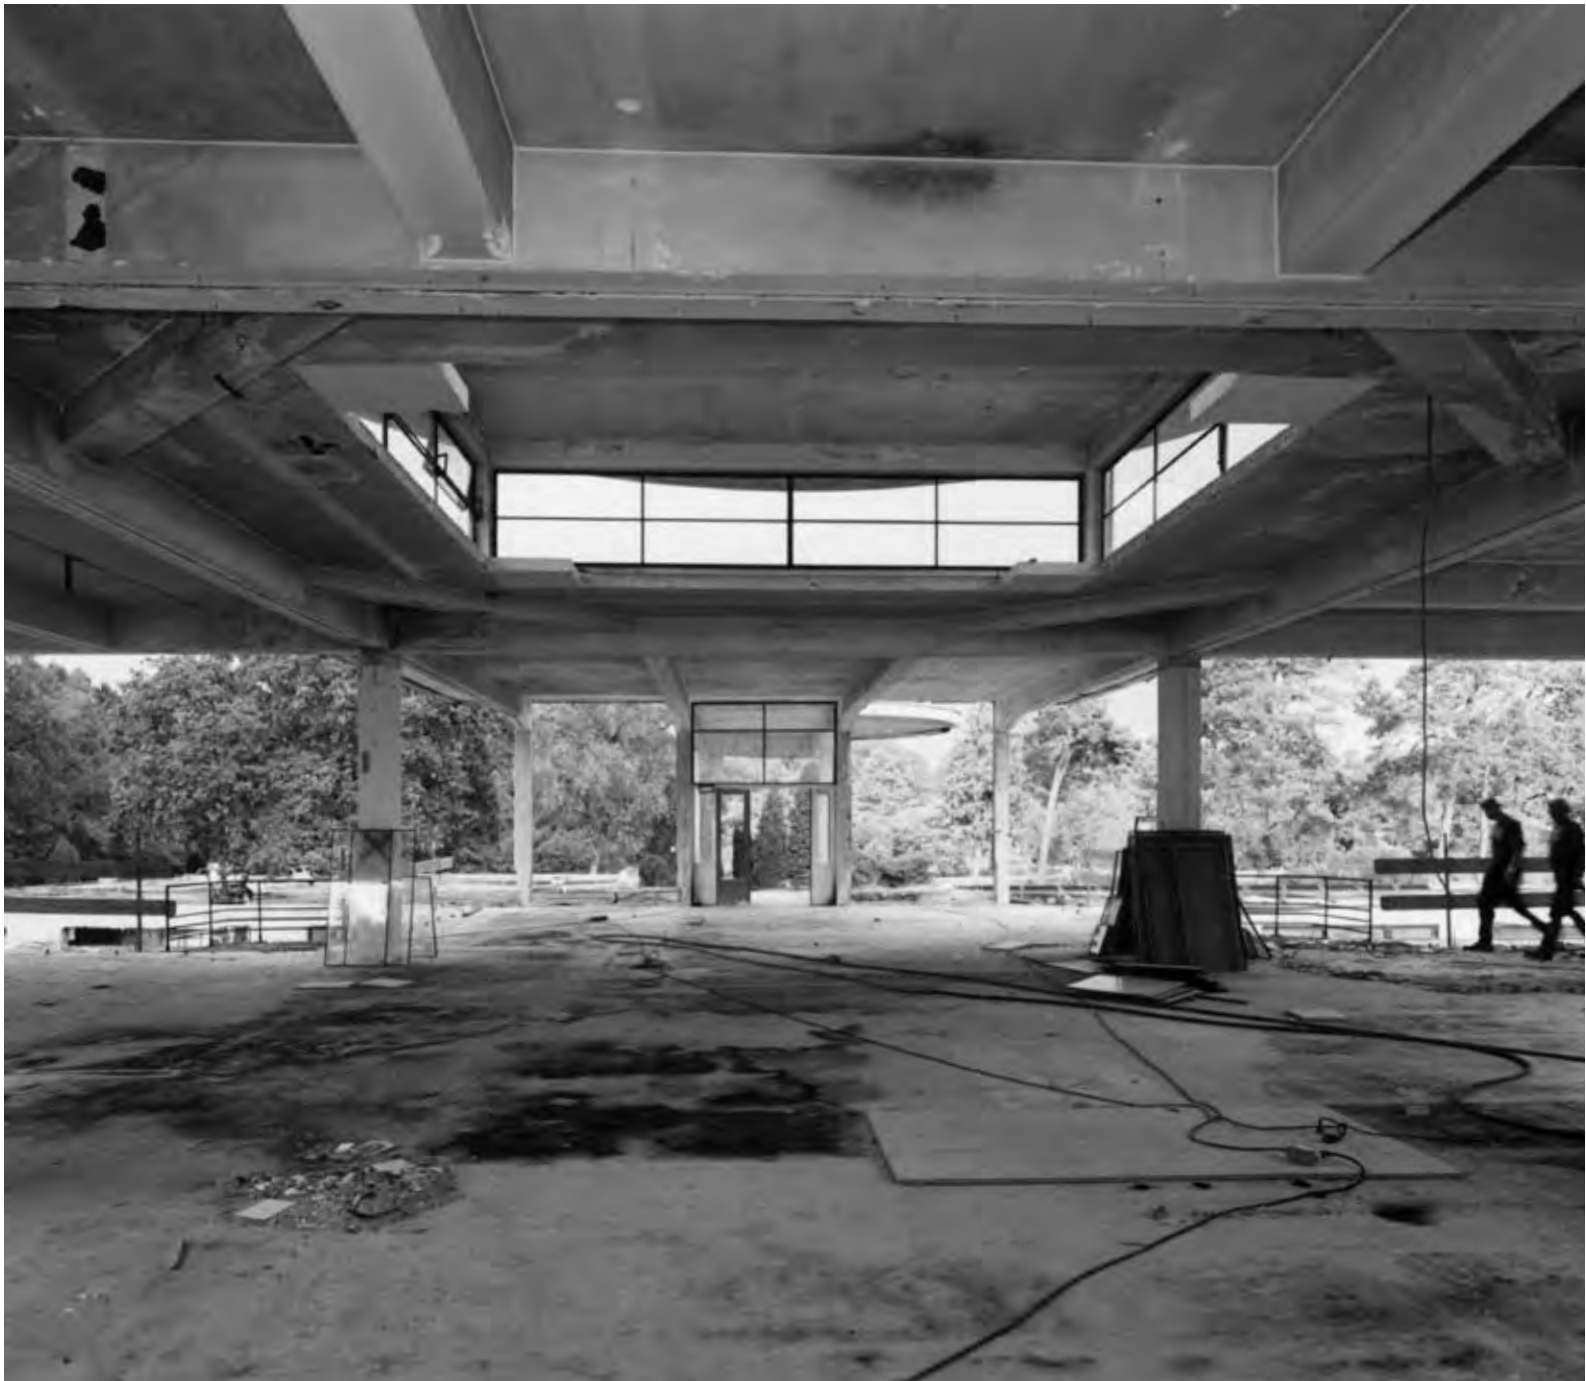
19 After the dismantling of the main building, little remained but the concrete skeleton, a few partition walls and parts of façades.

It was only following the dismantling that the fragility of the concrete frame of the main building became apparent amid the ruins. Because of continuous use most of the concrete had enjoyed an indoor climate so the condition of the supporting structure did not disappoint. According to structural

engineer ABT the replacement of a single girder and some repairs on two others was all that was needed. Four round concrete columns beneath the central part of the upper room, which had been added during construction because of cracking of the concrete frame, were replaced by steel columns filled with concrete.³

All the concrete was sand-blasted and repaired with classic methods: the defective concrete was cut away, the reinforcement depassivated and new mortar was applied, based on pure cement to prevent thermal expansion differences with the old. The original thickness of the render was used instead for an extra layer of sprayed concrete to ensure sufficient coverage and strength. With a thin layer of stucco covering the sprayed concrete

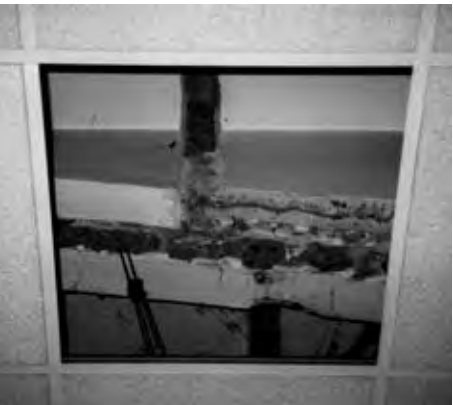
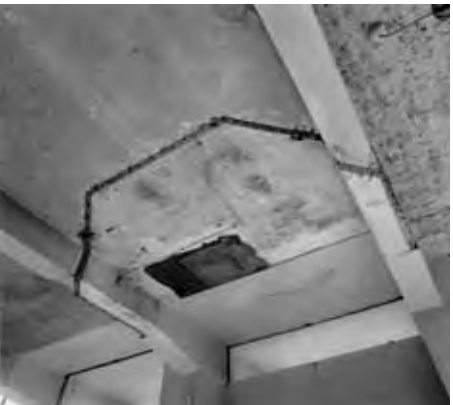
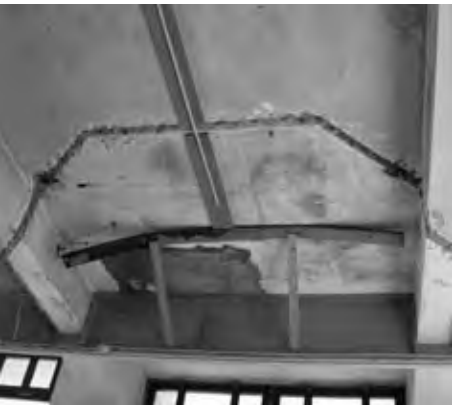
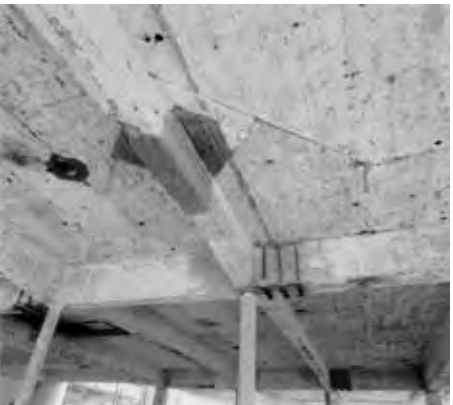
20 Destructive investigation could not start until late in the preparations for the restoration. The lifting of a ceiling panel revealed traces of an original partition wall that had been slotted into a relate in the concrete constructions above.

21–22 After the removal of the lowered ceilings, it was possible to read off the layout of many zones from the concrete rebates. Here the contour of the projection booth that was demolished at some point in time and the opening of the earlier ventilation system of the kitchens that had been filled in.

23 The hypothetical wall layout in the former kitchen wing could finally be verified, including the diagonal placing of the original food lifts. Repairs to the concrete skeleton in the central part of the main building, which were known from the correspondence between Duiker and Wiebenga, have become visible. Cracks in the supporting beams had been reinforced with steel braces and given extra support by four circular columns.

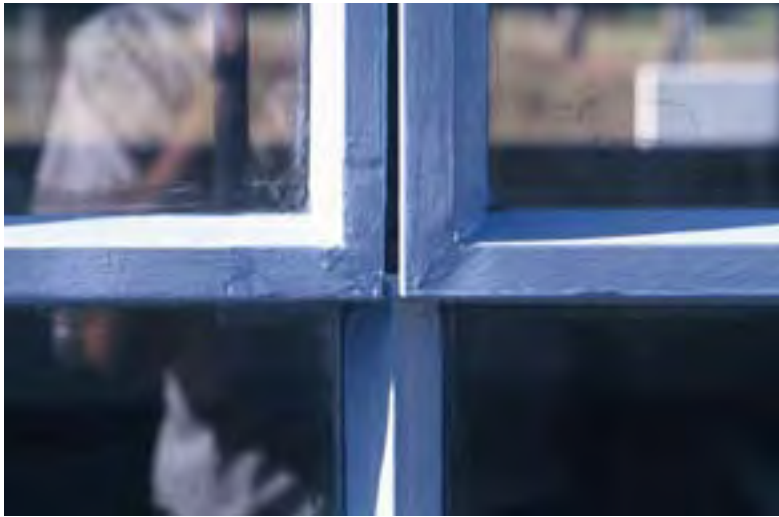
24 Detail of the restored, original façade of 25 mm profile steel. A single T-jamb appears beneath the two adjacent top hung sash windows.

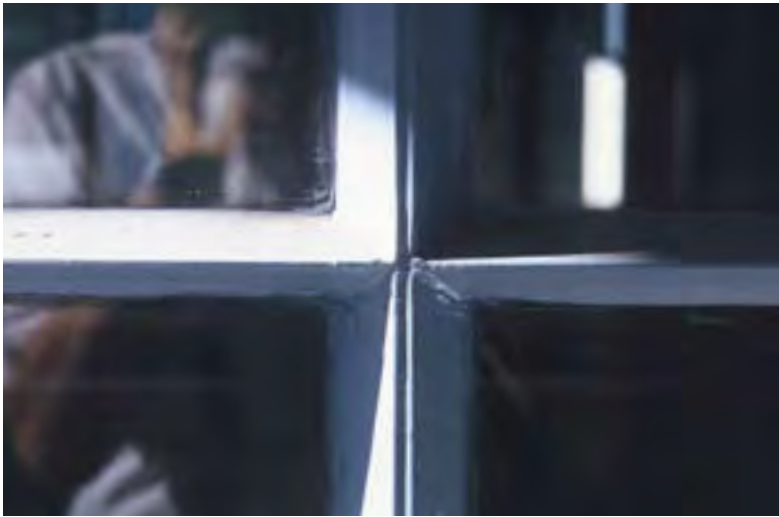
25 A similar detail of the new, reconstructed façade of 32 mm steel profile. The two L-shaped side jambs of two adjoining façade elements again form a kind of T-jamb, but with 3 mm clearance in between, which has been filled with a sealant.

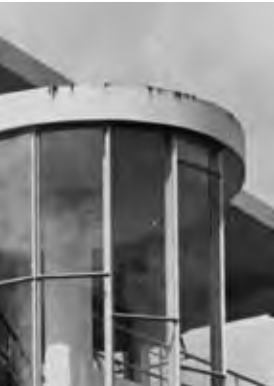
32 South wall of the main building, edge of the roof of the staircase with drip stains from melted roofing tar, 1930s.

The minimalism of Duiker’s architectural solutions is reflected in the absence of any roof edge detailing: the roofing was simply stuck on the stuccoed concrete roof edge and extended up to where it meets the stucco finish of the elevation. This meant that very shortly after completion the roof edges began to show signs of dirt and molten bitumen. In many places the roof edge was found to have a small concrete upstand, which was fitted later to combat this.⁸

The remnants of the concrete upstands were removed to restore the building’s appearance to that of the first building phase of 1928. The roofing was pulled over the roof edge again, although not before an aluminium strip was attached to which the roofing was fixed which reduces the risk of damage from, say, ladders against the roof edge. The joint between the aluminium strip and the stucco has been sealed with an elastic sealant.

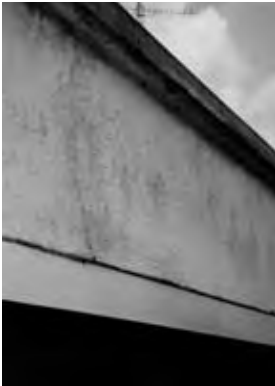
33 At a later stage a plastered drip edge was applied to a large part of the building, which gave it a very different appearance.

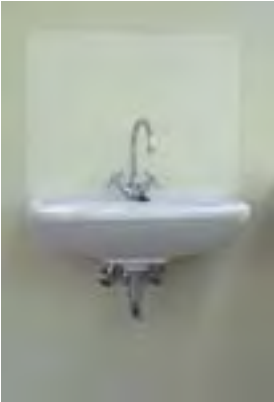
36 Concrete enamel water-proof finish for the walls, which has been meticulously restored. Because the substrate is also different for today's wall plaster, careful planning was required.

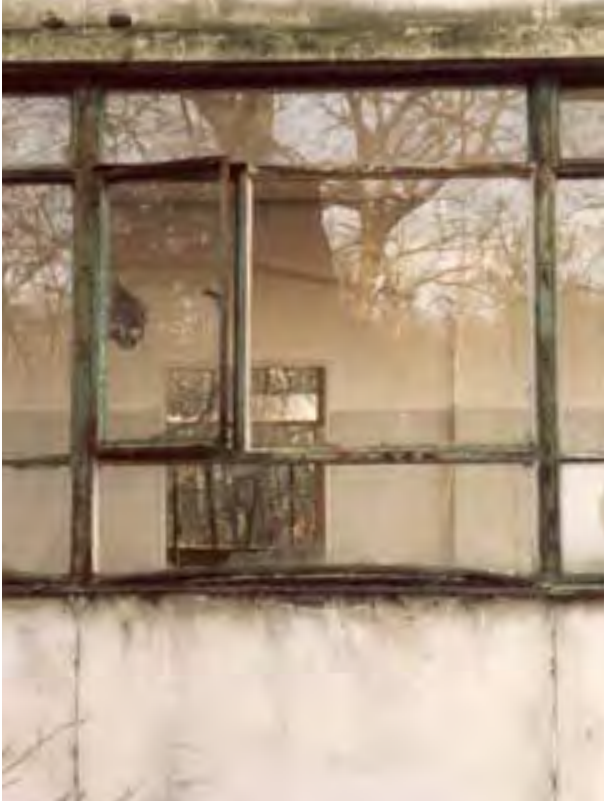
40 A standard window from the corridor walls in the Dresselhuys Pavilion. They were seriously damaged because this side was not protected by a roof overhang. Inadequate profiling meant that the window sills had folded upwards, often leaving the ground sills wet. The consequences can be seen from the swollen steel work of the sills.

The disintegration of the bottom sills into a millefeuille of corrosive steel had been caused by the contraction of the sheet metal sill, which had been too thin and in which water had pooled. This is why new, tightly crimped steel weather sills have been installed underneath the window frames. The original, continuous profile has been replaced by two independent sections which have been thermally separated by a synthetic strip. Taken together the two parts closely resemble the form of the original window sill. Many of the window hardware could also be repaired and re-used.

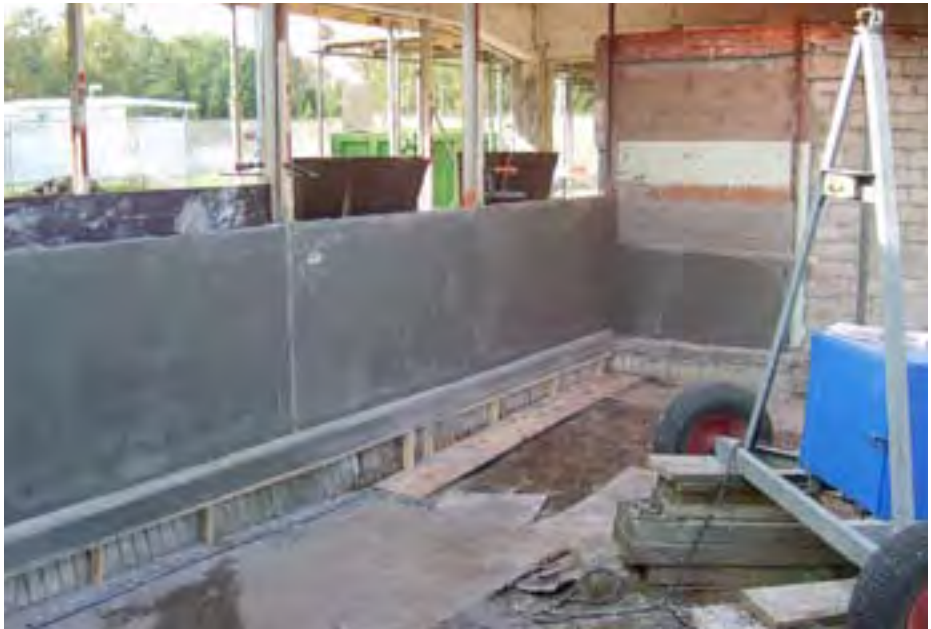
During the restoration it was discovered that the external wall leaf had been made on site of cement plaster on reinforcement bars. At most of the corners the original external wall leaves could be repaired and thus preserved. The somewhat battered exterior has been carefully preserved in order to show that the pavilion has a history. The other external wall leaves were so badly damaged that they had to be replaced by new ones drawing on the original, albeit improved principle.

41 The new structure of the parapets. Right the original lime-sand inner cavity leaf. In the middle the new structure with (from inside to outside): cement rendering coat, cavity, thin insulation panel, galvanized steel reinforcement (not visible), stainless steel clayed wire mesh and cement plaster. Left the final result.

wall leaves could only be rendered from the outside and was partially exposed inside the cavity wall. Additional protection against corrosion now comes from horizontal zinc-coated steel bars, which were inserted through the holes in the INP posts, a stainless steel clay wire mesh and a zinc-coated steel reinforcement net on the outside. A slender insulating panel has been inserted into the cavity wall. The ventilation facilities could be reproduced and the air flow has been improved by making larger slots in the columns.
