Sanatorium Zonnestraal

the history and restoration
of a modern monument

179	4.3	The Restoration Concept Wessel de Jonge and Hubert-Jan Henket
185	4.4	The Restoration Wessel de Jonge and Hubert-Jan Henket

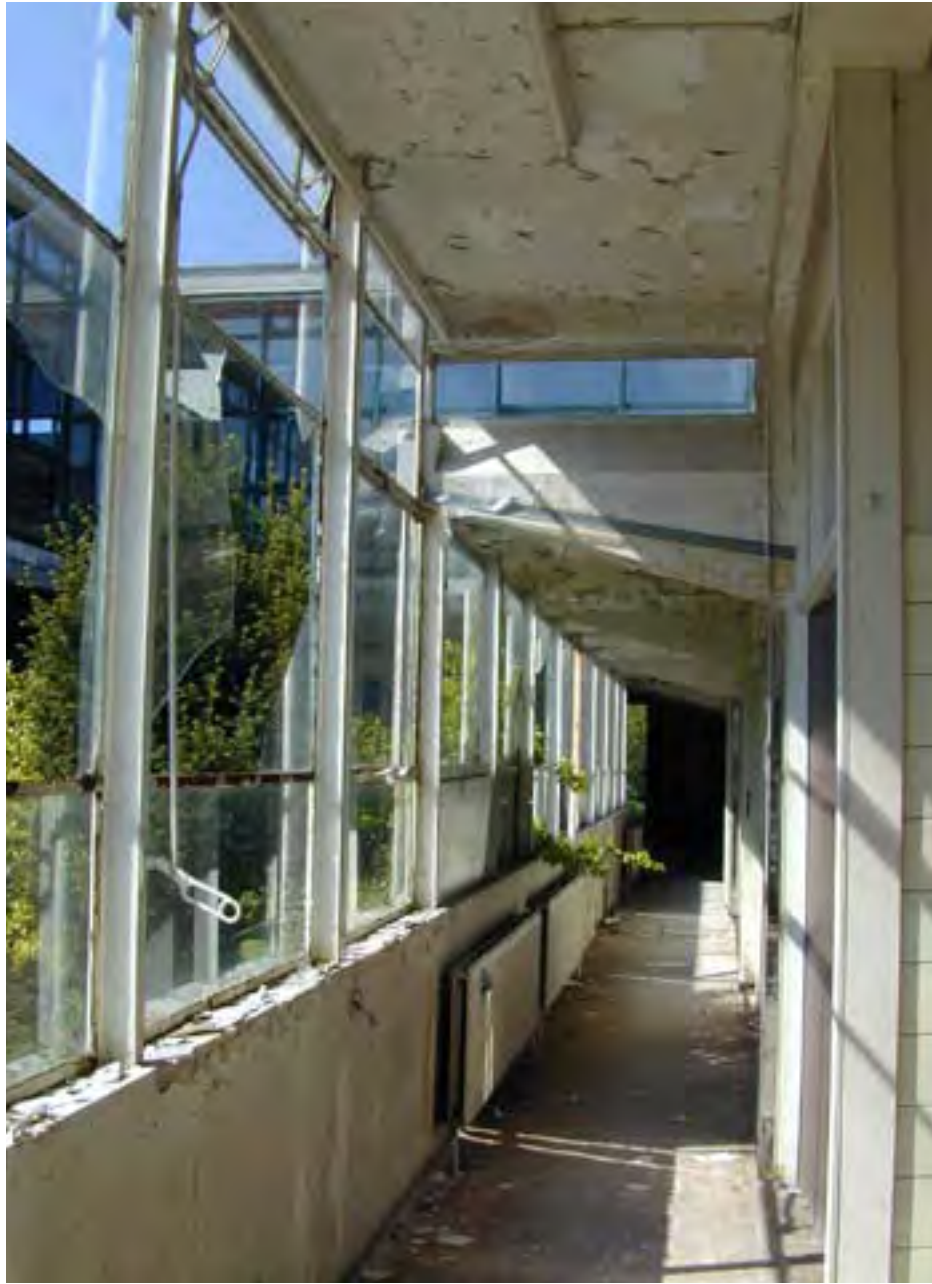
27 During the dismantling, of the main building a comprehensive record of the hardware was kept. Many of the industrial products of the time proved to be no longer available and have been replaced by modern equivalents.

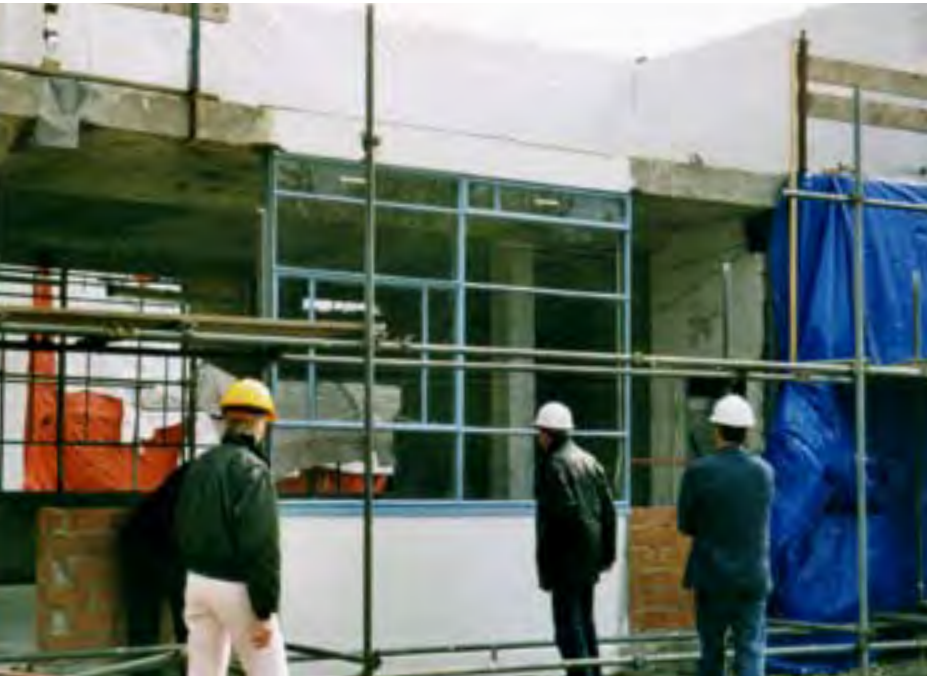
28 In test cases the attempt has always been made to take into account an integral part of the building, as here a part of the façade from the foundation to the roof. The plaster, the finishing of the frames with alkyd paint and the glazing were evaluated.

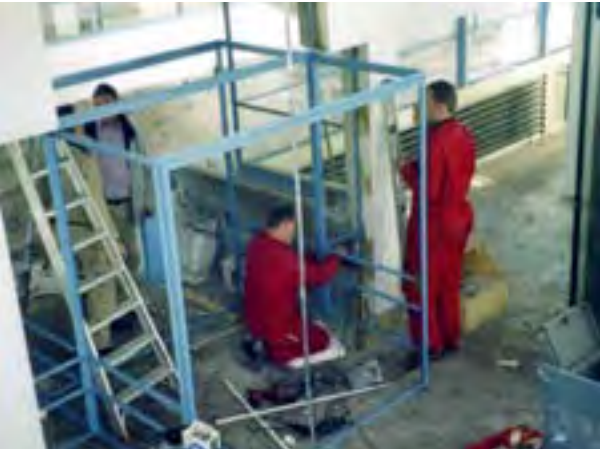
29 Placing of the storm porch in the administrative wing by the frame supplier Van der Vegt, 2003.

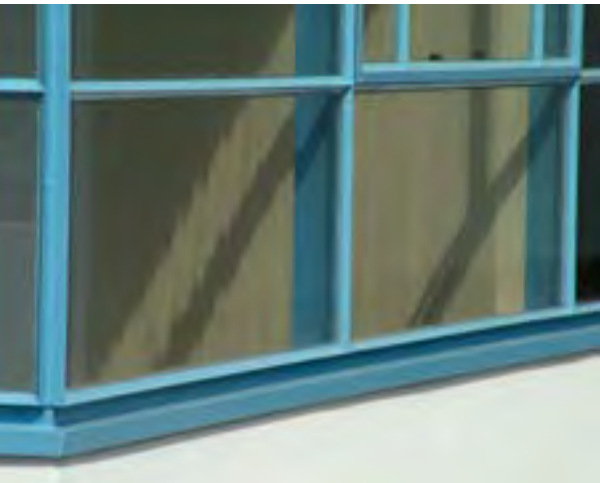
30 Drawn glass causes distortion in the view both looking outside from inside and, as here, looking inside from outside. The texture of this glass makes it more tangible than modern types of glass.

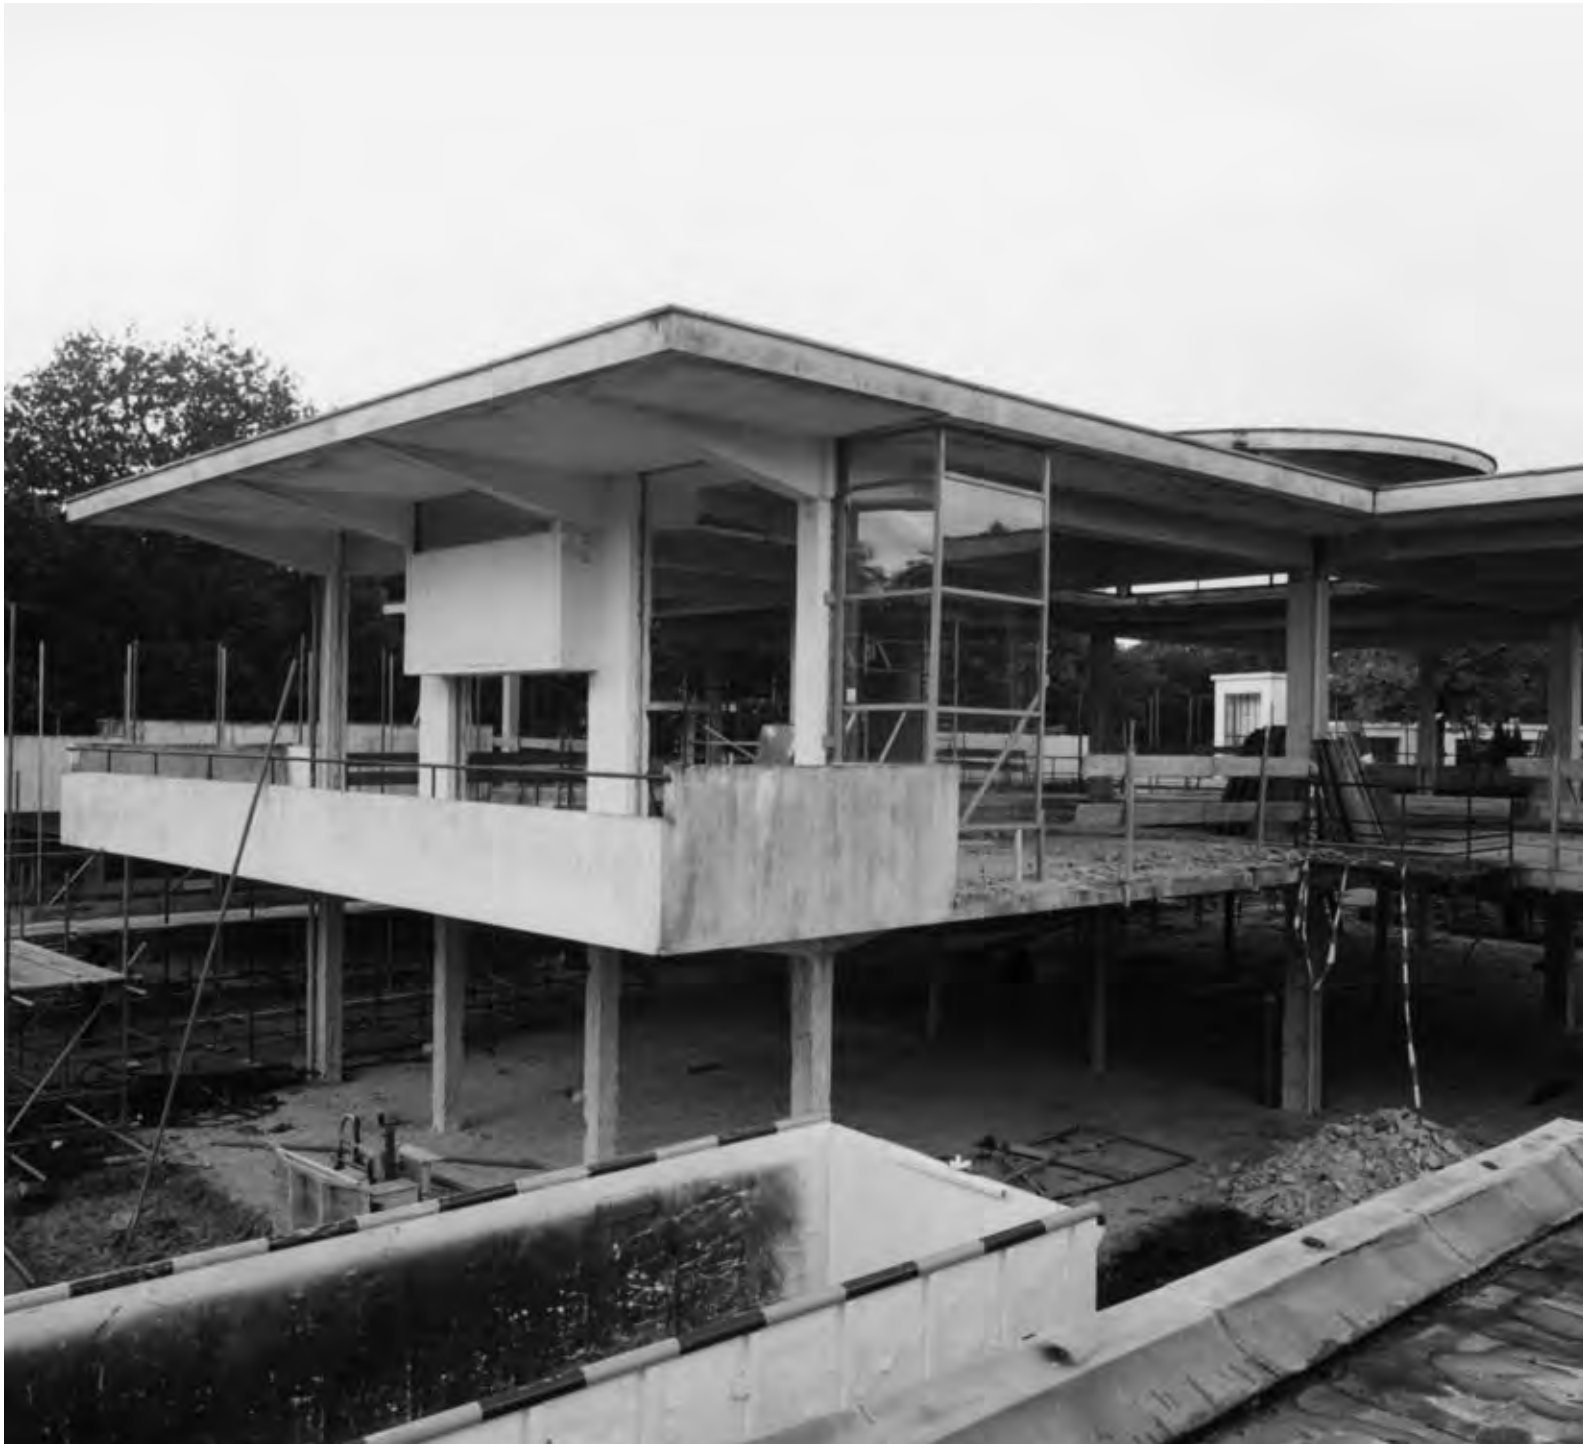
31 The testing of the window panes in the corner of the large hall. The glazing was always tested on corner locations so that the view through two panes of glass could be evaluated.

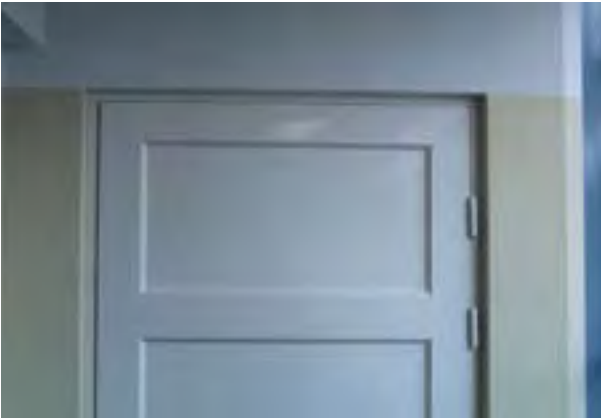
34 Where no high sound-proofing standards apply, newly made panel doors have been used.

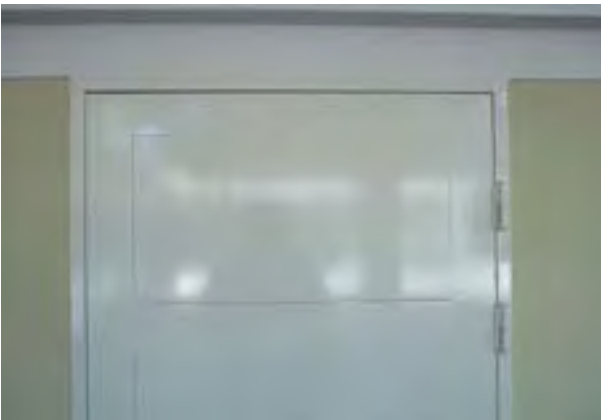
35 Where high soundproofing standards do apply, solid multi-plex doors have been used, to which panels have been glued with the same pattern as the original ones but in reverse.

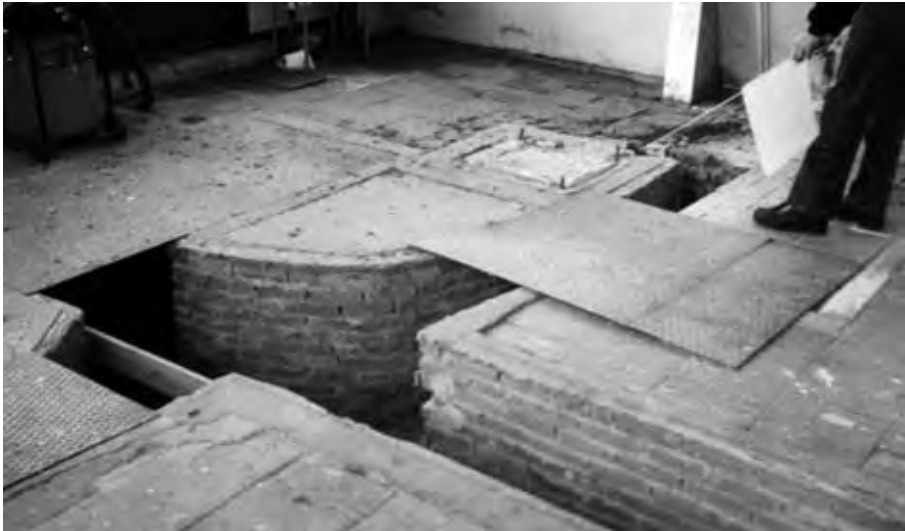
42 Documenting the underground air ducts in the carpentry workshop. They were covered with steel checker plates.

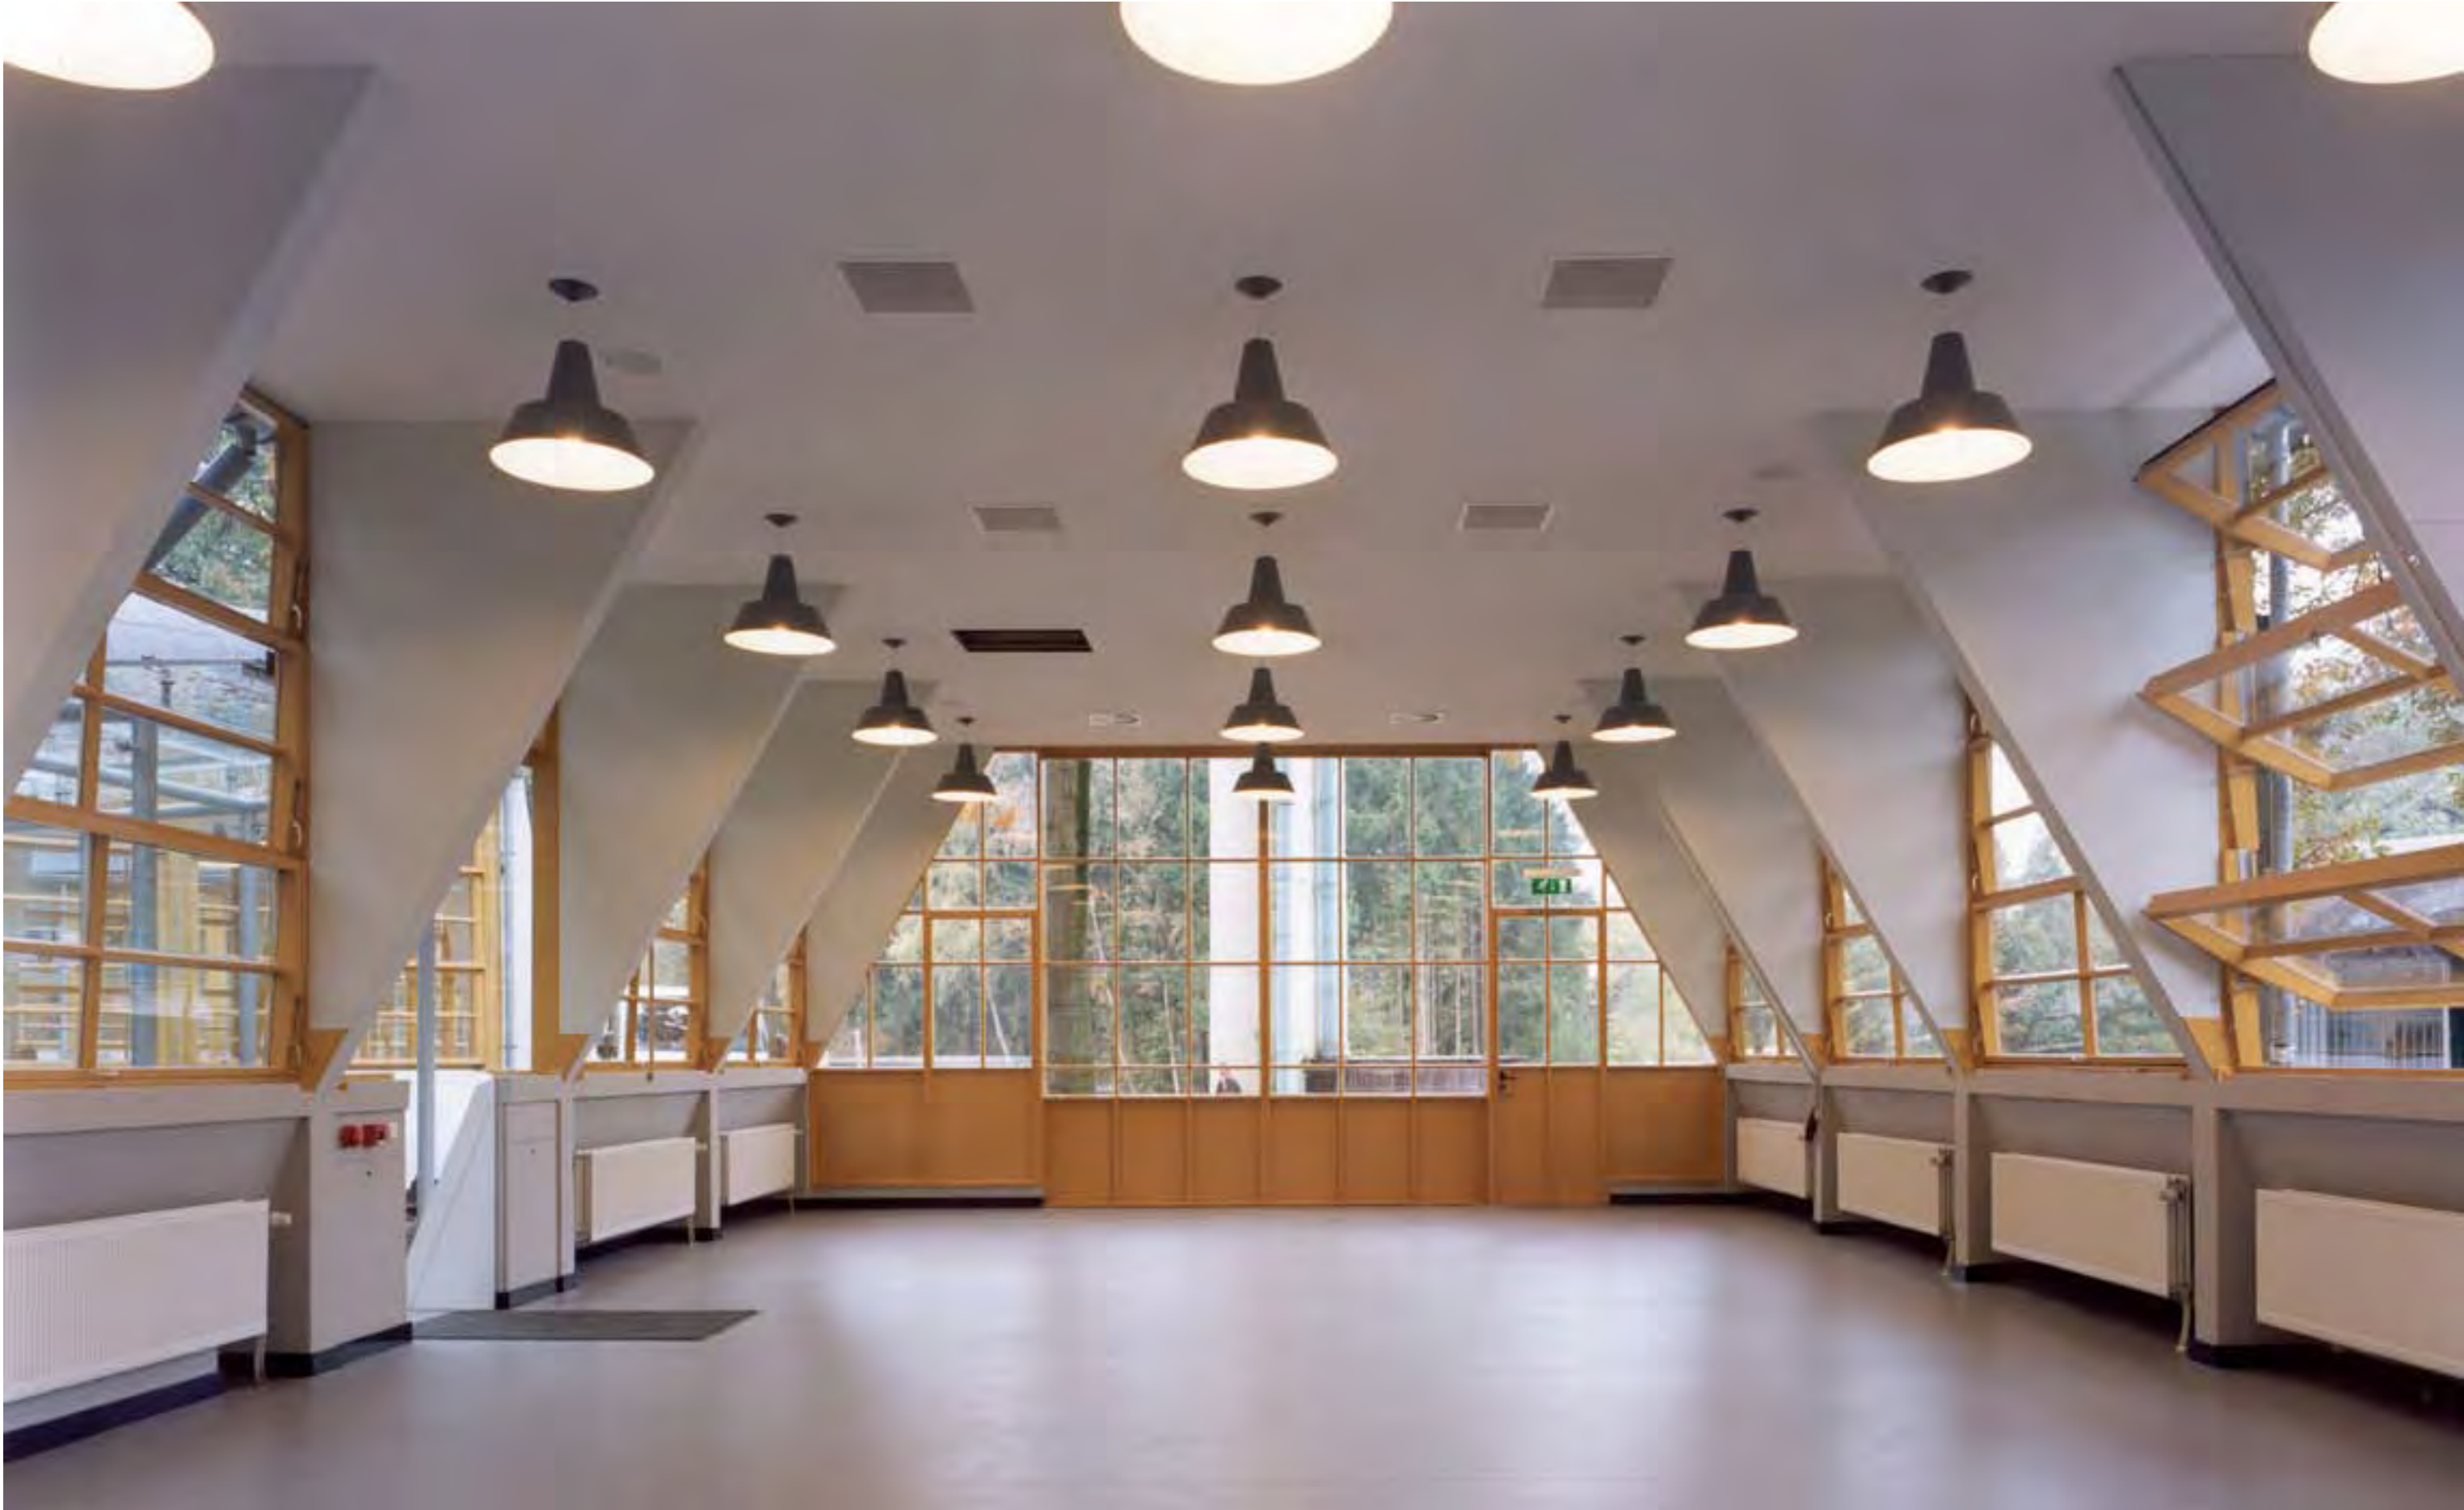
44 The central workshop after restoration. The light fittings are copies, as in the main building, and fitted with PL lamps in a warm light colour.

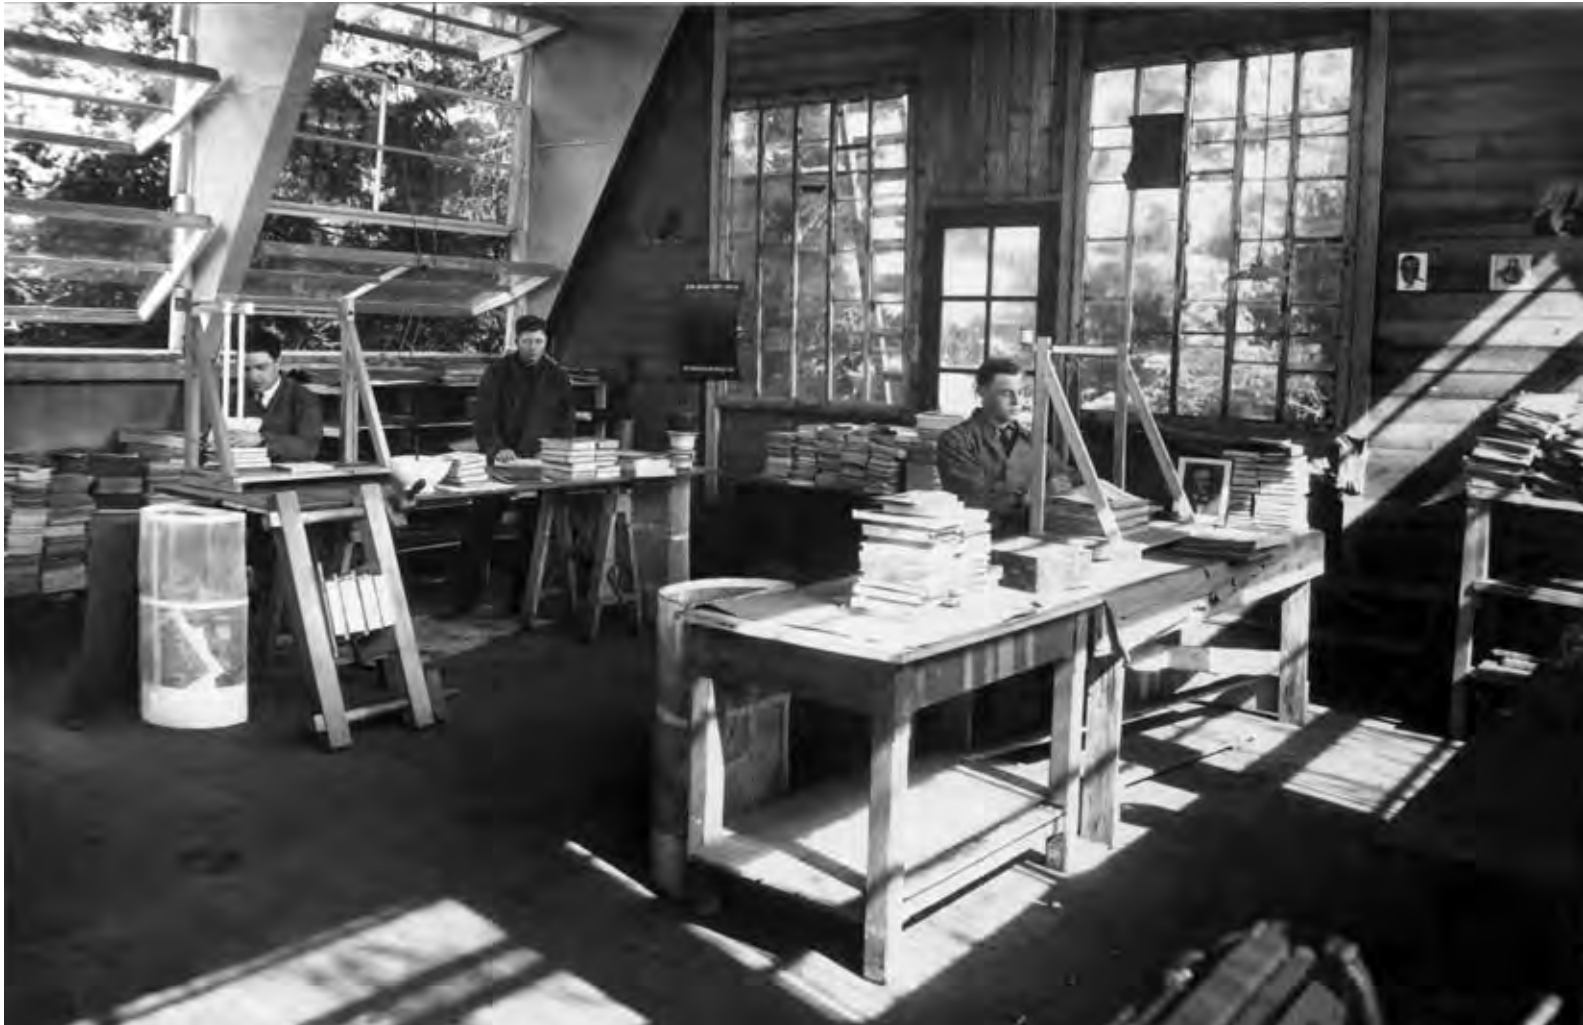
45 The longitudinal facades of all four workshops consisted of abutting pivoted sash windows without a middle rail. During the restoration it required a lot of patience and ingenuity to determine the details.
